Inspection Report

Property Address:
1956 Harvard Avenue East
Seattle WA 98102

Pristine Sweeps, LLC

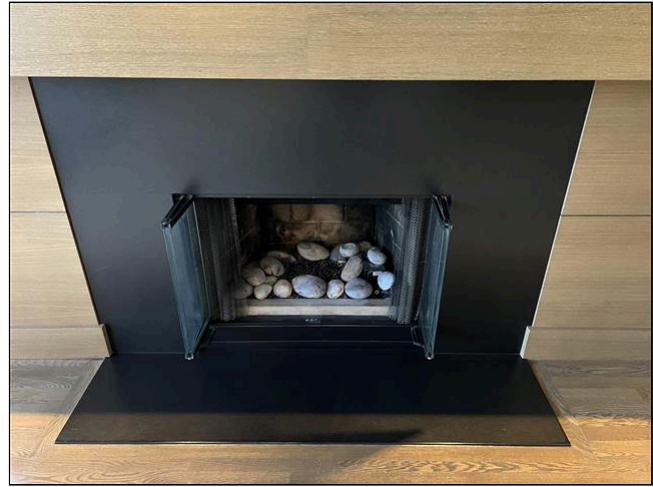
2.1.A Item 1(Picture)

A prefab or "zero clearance" fireplace is manufactured in a factory and installed with a metal chimney pipe. The body (or chase) of the chimney is usually wood framing with a metal chase cover and metal chimney cap. The interior of the fireplace is usually insulated with refractory panels with a stamped brick pattern.

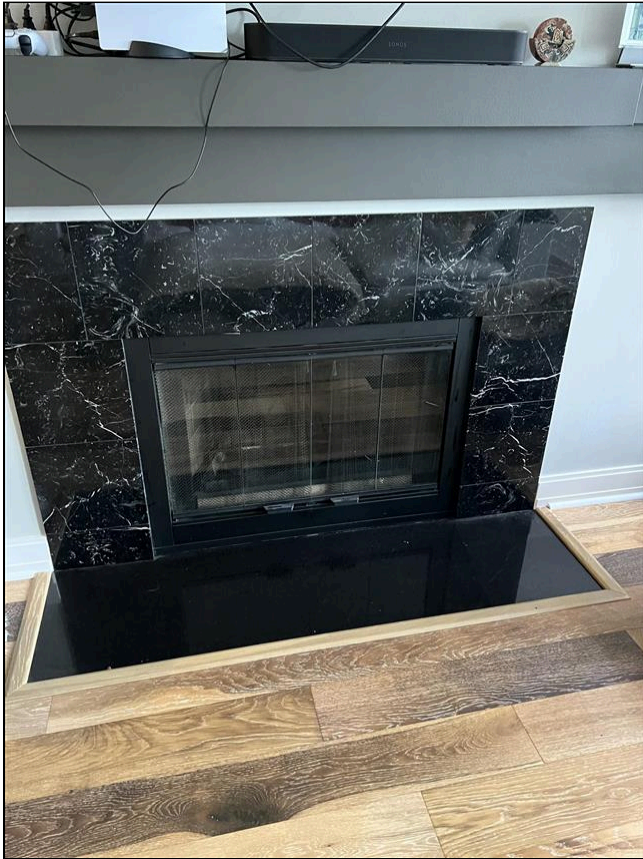
2.1.B Item 1(Picture)

A prefab or "zero clearance" fireplace is manufactured in a factory and installed with a metal chimney pipe. The body (or chase) of the chimney is usually wood framing with a metal chase cover and metal chimney cap. The interior of the fireplace is usually insulated with refractory panels with a stamped brick pattern.

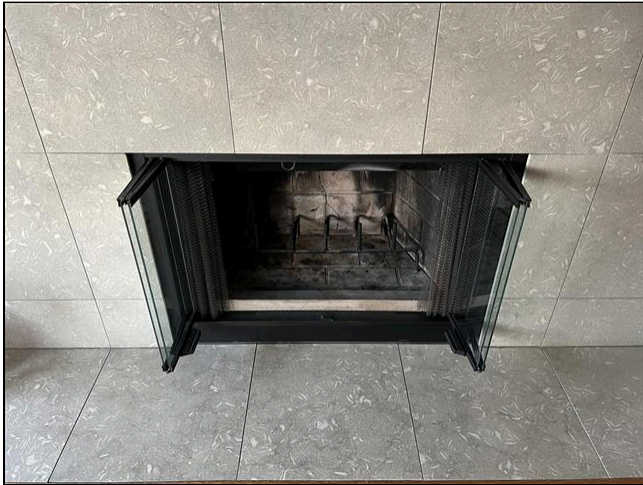
2.1.C Item 1(Picture)

A prefab or "zero clearance" fireplace is manufactured in a factory and installed with a metal chimney pipe. The body (or chase) of the chimney is usually wood framing with a metal chase cover and metal chimney cap. The interior of the fireplace is usually insulated with refractory panels with a stamped brick pattern.

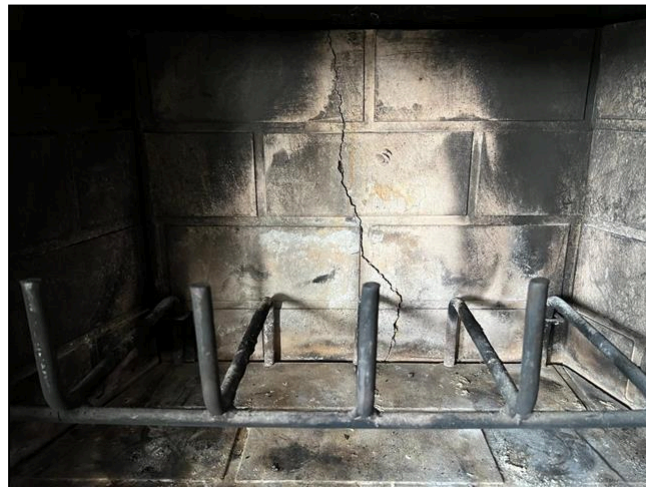
2.3.C Item 1(Picture)

The firebox is the "burn chamber" of your combustion system. It is constructed of a sheet metal backing and finished with insulative refractory panels, or insulative metal panels.

The refractory pre-fab firebox panel(s) have cracked. These panels need to be intact for the fireplace to operate as intended.

Pre-fab fireplace refractory panels should be replaced with original manufacturer panels or an approved replacement panel.

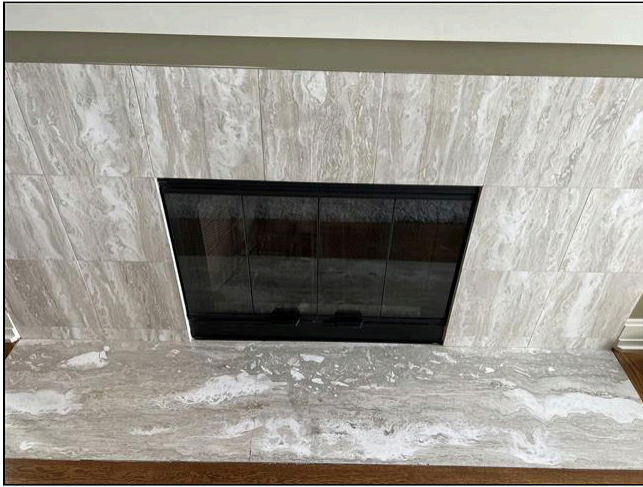
2.1.D Item 1(Picture)

A prefab or "zero clearance" fireplace is manufactured in a factory and installed with a metal chimney pipe. The body (or chase) of the chimney is usually wood framing with a metal chase cover and metal chimney cap. The interior of the fireplace is usually insulated with refractory panels with a stamped brick pattern.

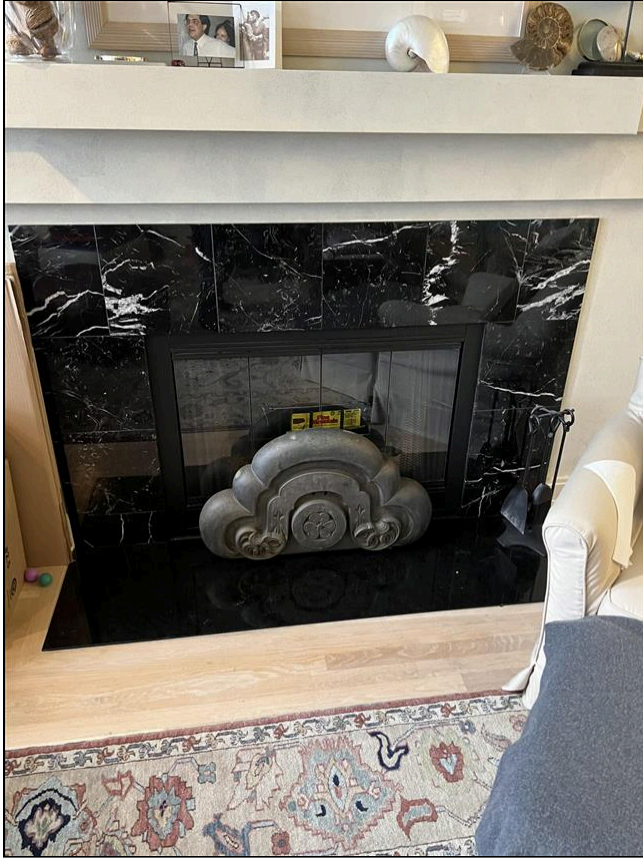
2.1.E Item 1(Picture)

A prefab or "zero clearance" fireplace is manufactured in a factory and installed with a metal chimney pipe. The body (or chase) of the chimney is usually wood framing with a metal chase cover and metal chimney cap. The interior of the fireplace is usually insulated with refractory panels with a stamped brick pattern.

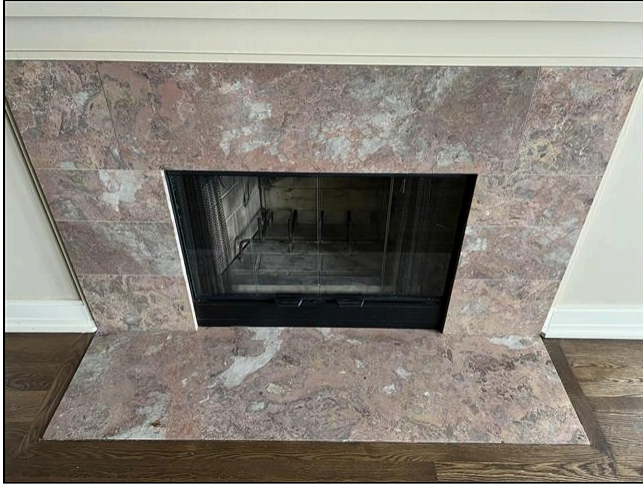
2.1.F Item 1(Picture)

A prefab or "zero clearance" fireplace is manufactured in a factory and installed with a metal chimney pipe. The body (or chase) of the chimney is usually wood framing with a metal chase cover and metal chimney cap. The interior of the fireplace is usually insulated with refractory panels with a stamped brick pattern.

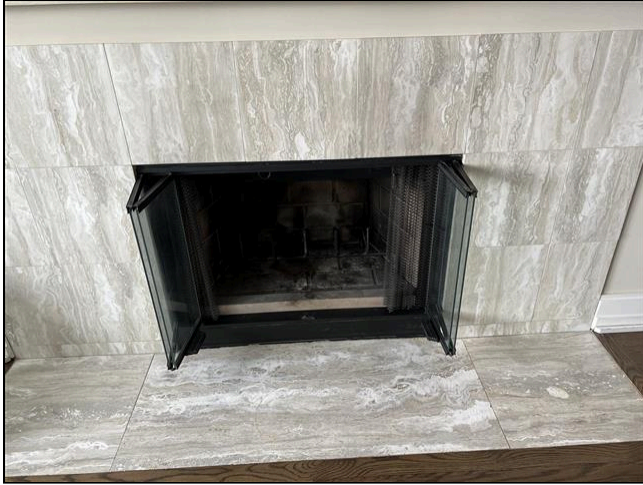
2.1.G Item 1(Picture)

A prefab or "zero clearance" fireplace is manufactured in a factory and installed with a metal chimney pipe. The body (or chase) of the chimney is usually wood framing with a metal chase cover and metal chimney cap. The interior of the fireplace is usually insulated with refractory panels with a stamped brick pattern.

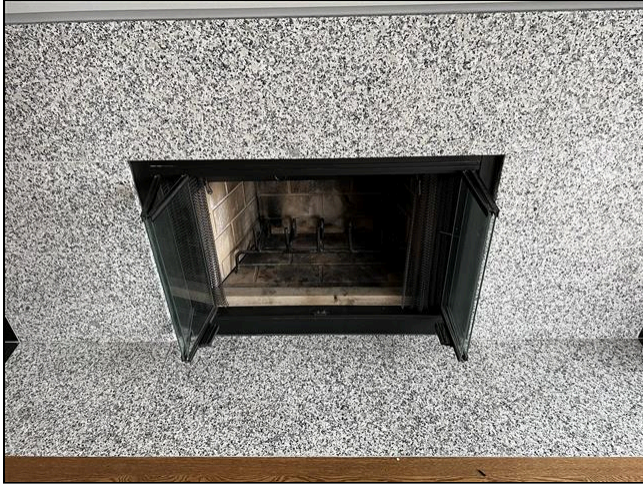
2.1.H Item 1(Picture)

A prefab or "zero clearance" fireplace is manufactured in a factory and installed with a metal chimney pipe. The body (or chase) of the chimney is usually wood framing with a metal chase cover and metal chimney cap. The interior of the fireplace is usually insulated with refractory panels with a stamped brick pattern.
